**Re: Chevron Mining, Inc. (CMI), Questa Mine; MSGP; SIC 1061; NPDES Compliance Evaluation Inspection (CEI); NMR053300; July 24 thru July 26, 2018**

## NPDES Compliance Inspection Report

## NPDES Industrial Storm Water Checklist (MSGP)

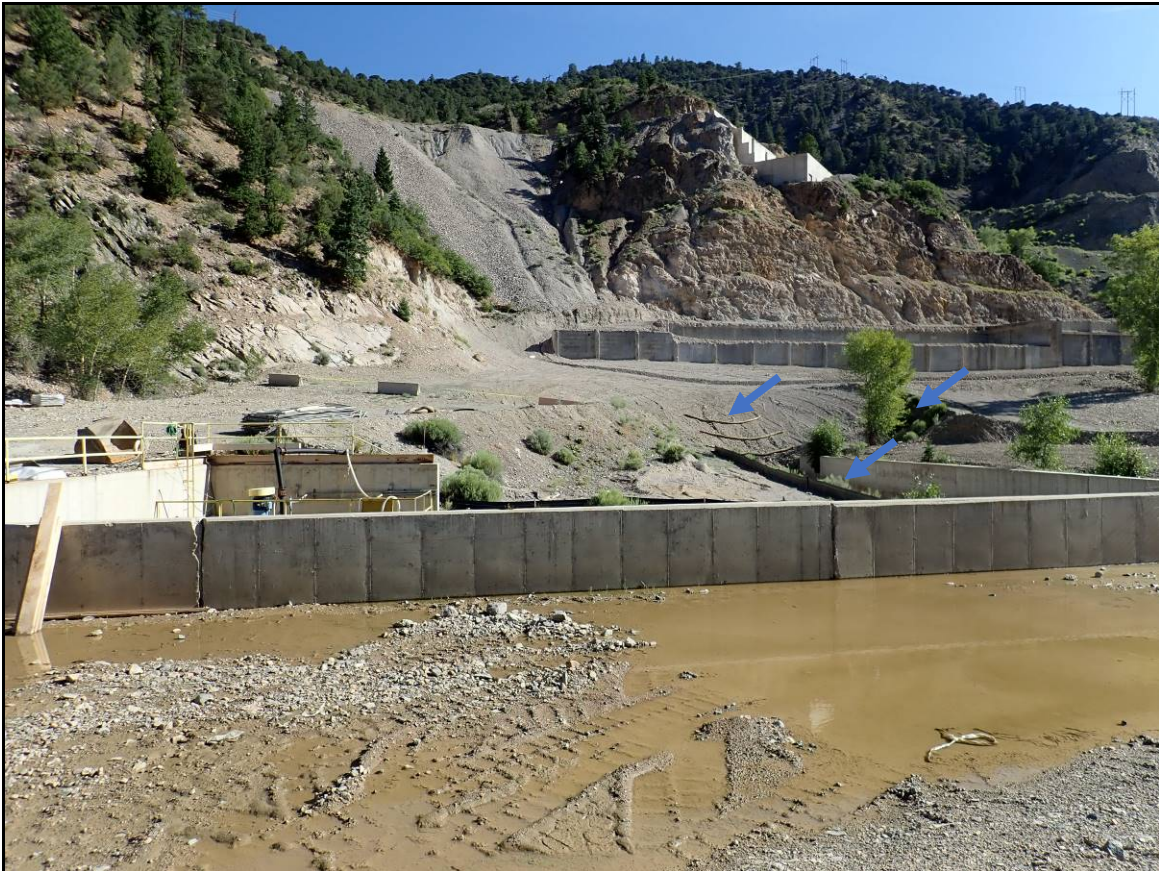
Location: CMI Questa Mine, Mine Site, West Gate Laydown Area, Unit 1

Subject: Looking north in southwest portion of Unit 1 at erosion rills and gullies on slopes; remaining mill structures, including concrete structure that collects water. Arrows point to ditch, straw wattles and silt fence controls.

Unit 1: Runoff that enters or occurs in the West Gate Laydown area in Unit 1 is not directed toward Outfall 005 covered by the NPDES Individual Permit NM0022306 as described in SWPPP or as shown on SWPPP Mine Site Map. The West Gate Laydown area in Unit 1 was not covered on the day of this inspection by another NPDES permit based on discussions with Permittee Representatives. Collected water existed in a remaining Mill Area concrete structure in the West Gate Laydown area. Wet soils and erosion rills indicated some flow in the West Gate Laydown area would be toward the southern mine property boundary along NM 38 and entrance. Water had ponded in a low area near the entrance to NM 38. No evidence of discharge was observed from the West Gate Laydown Area in Unit 1. SWPPP Mine Site Map was not updated to include flow directions, berms, ditches, wattle, and silt fence controls. Inspection of the West Gate Laydown area is not documented on Routine Facility Inspection reports. Photos #1 thru #4 for the West Gate Laydown area are attached.

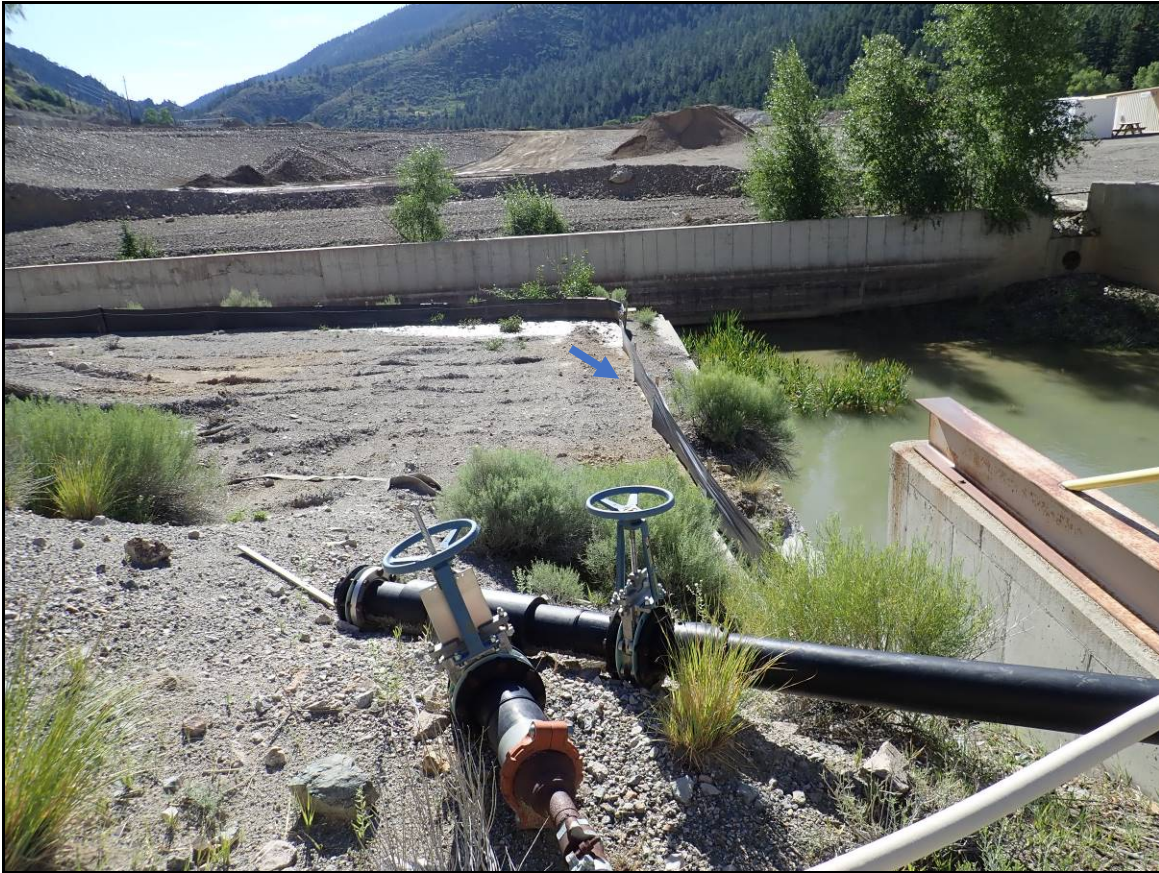
**NMED/SWQB  
Official Photograph Log  
Photo # 2**

Location: Chevron Questa Mine, Mine Site, West Gate Laydown Area, Unit 1

Subject: Looking east from area shown in previous photo, area in background is active construction and support activity related to the Enhanced 005 Catchment project covered under separate NPDES permits. Foreground is remaining concrete structure and collected water. Arrow points to silt fence control.

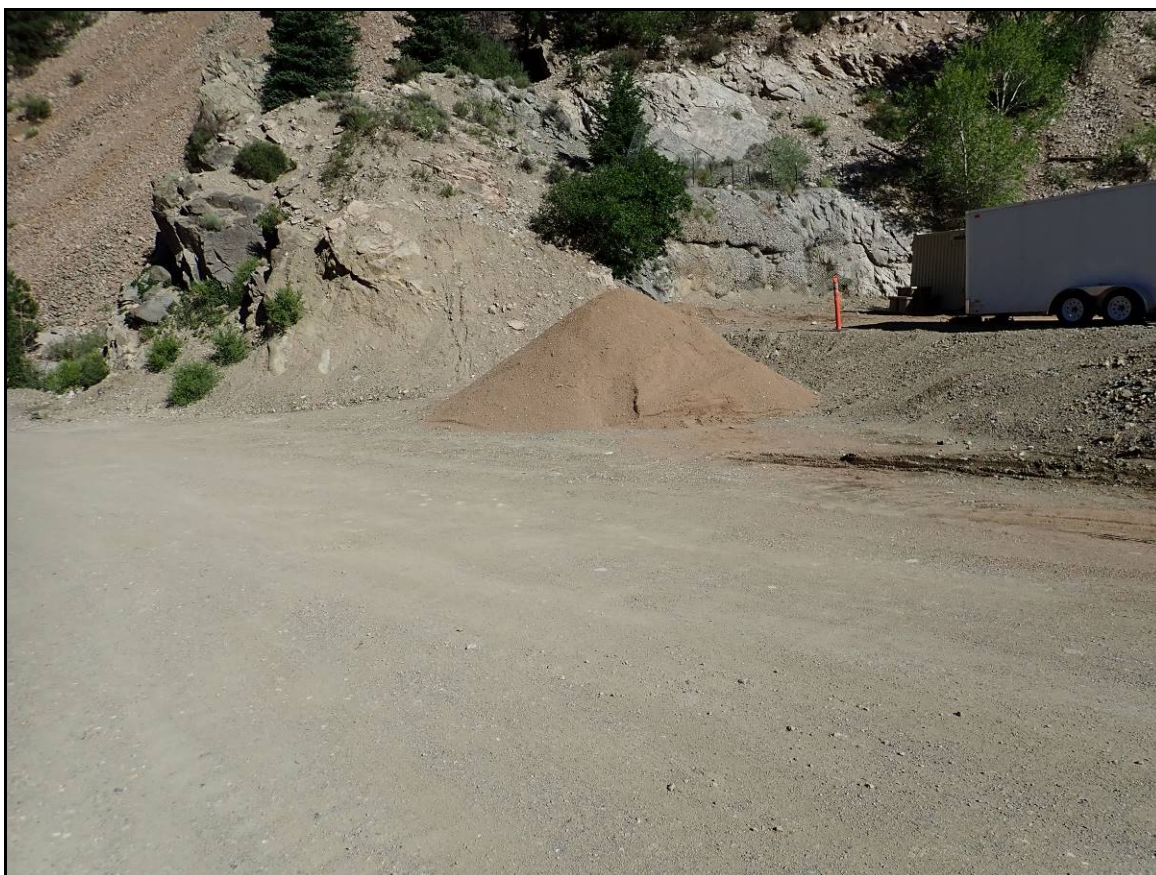
**NMED/SWQB  
Official Photograph Log  
Photo # 3**

Location: Chevron Questa Mine, Mine Site, West Gate Laydown Area, Unit 1

Subject: Material storage pile with fine-grained solids near entrance driveway to West Gate Laydown Area. No containment or sediment controls observed for pile.

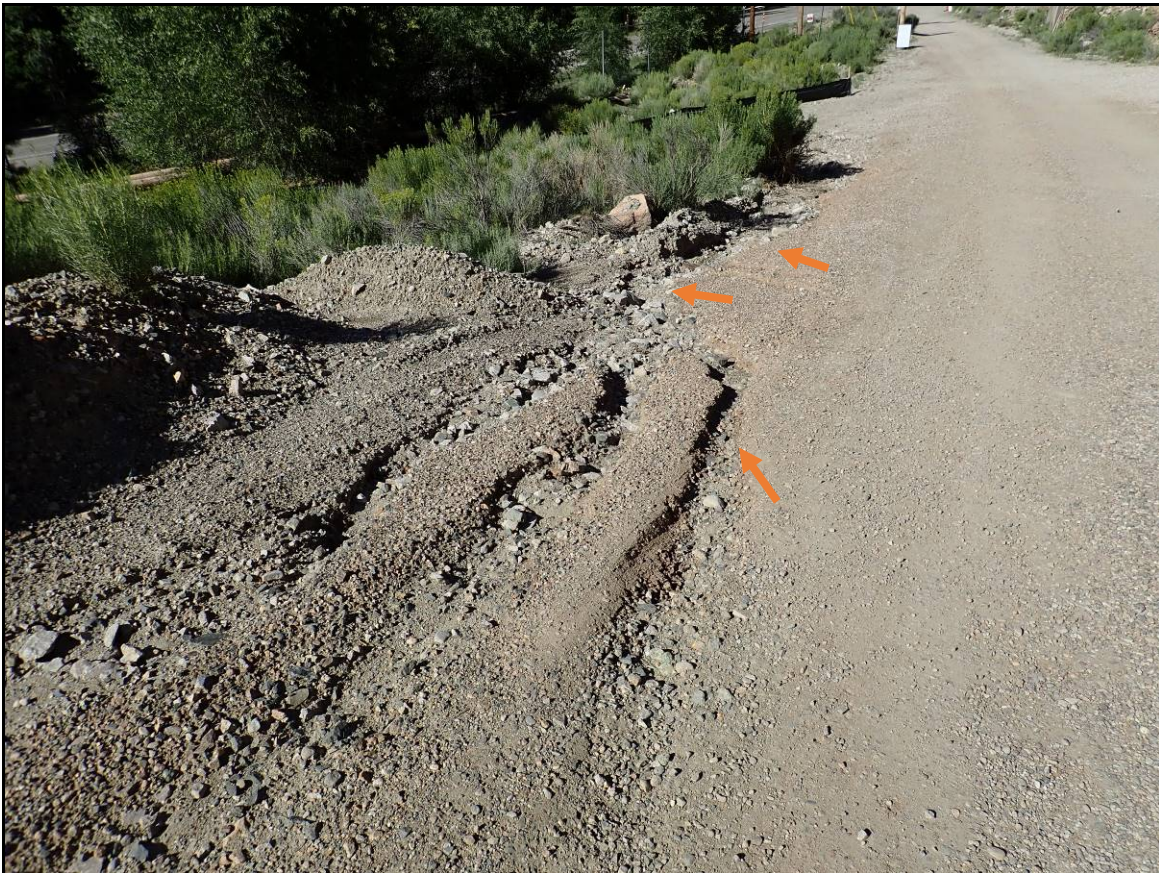
**NMED/SWQB  
Official Photograph Log  
Photo # 4**

Location: Chevron Questa Mine, Mine Site, West Gate Laydown Area, Unit 1

Subject: Looking west, arrow points to erosion rills indicating runoff flow direction along the driveway toward the West Gate Laydown Area entrance and south toward property boundary. Rills were not observed to continue to entrance or property boundary. Silt fence and berm controls existed along southern property boundary.

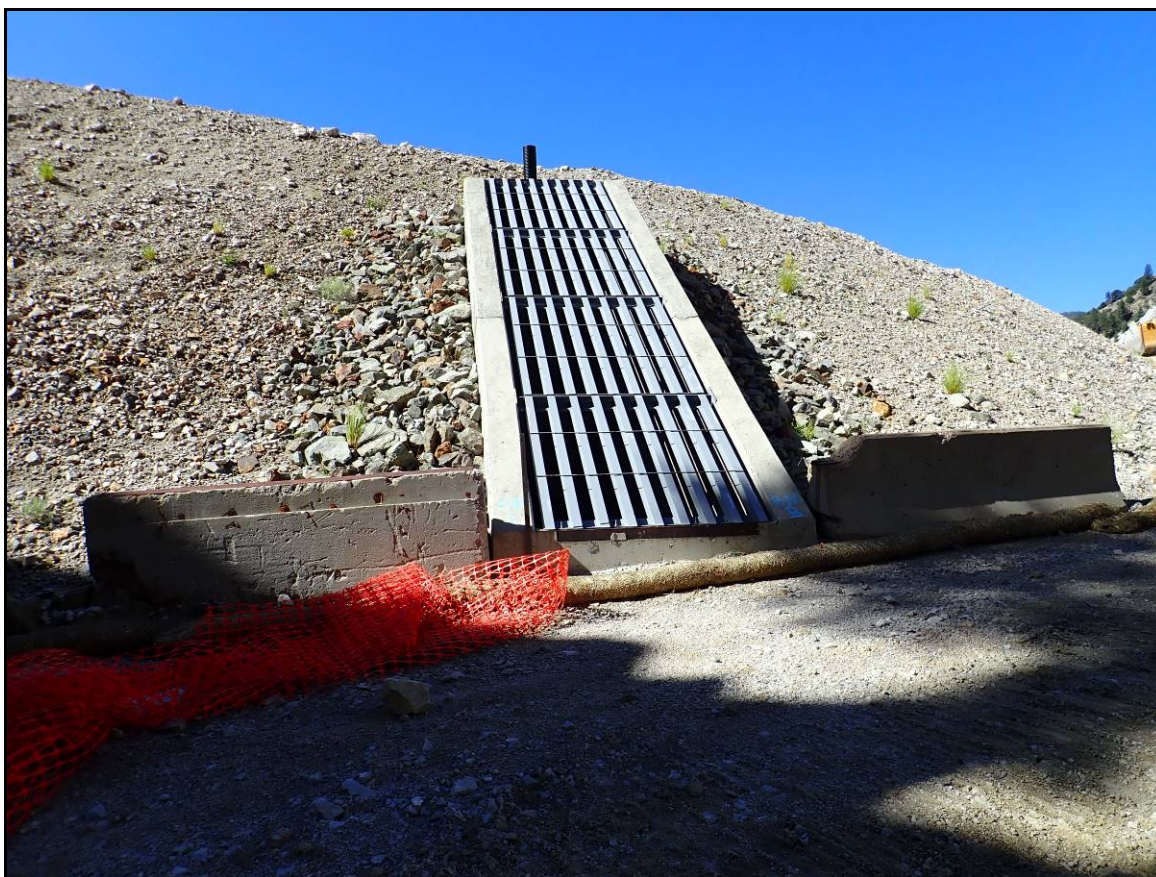
**NMED/SWQB  
Official Photograph Log  
Photo # 5**

Location: Chevron Questa Mine, Mine Site, Sulphur Gulch South Rock Pile, Unit 5

Subject: Culvert inlet structure at toe of Sulphur Gulch South Rock Pile and associated catchment in Unit 5.

Potential Additional Outfall: CMI's NOI and SWPPP describes two outfalls for the runoff from the Eastern Diversion Ditch and tailing facility area (Outfall SWED at Latitude 36.6973°, Longitude -105.6202°) in Unit 14 and runoff from Capulin Rock Pile and Canyon to stormwater catchments (Outfall SWLC at Latitude 36.6987°, Longitude -105.5492°) in Unit 10. A culvert structure in Unit 4, approximately Latitude 36.694987°, Longitude -105.497526°, exists at the base of the Sulphur Gulch South Rock Pile which has the potential to convey stormwater discharge off the property boundary to roadway ditches and roadway culvert crossings to Red River. The structure is not discussed in SWPPP (e.g., purpose of structure, flow direction, elevations, estimated water levels needed for discharge, etc.). Photos #5 and #6 of the potential outfall structure are attached.

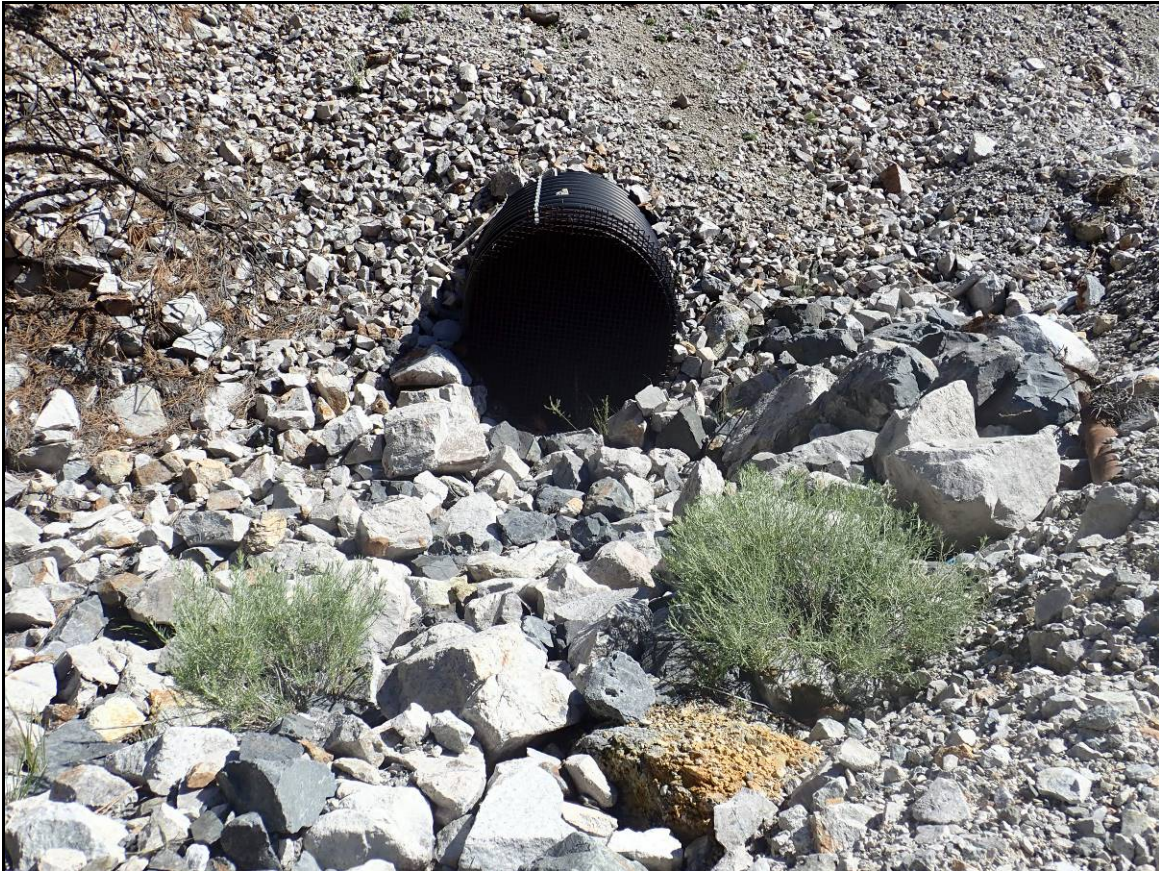
**NMED/SWQB  
Official Photograph Log  
Photo # 6**

Location: Chevron Questa Mine, Mine Site, Westgate Laydown Area, Unit 5

Subject: Culvert outlet structure in roadside rockpile highway and entrance berm. Rock armors the shallow channel directly below the outfall. The shallow channel continues toward the highway and appears partially interrupted by a low berm from the highway. No evidence of discharge was observed during this inspection. This outlet structure and the shallow channel is not shown on the SWPPP Mine Site Map and is not identified as a potential outfall in the SWPPP or NOI.

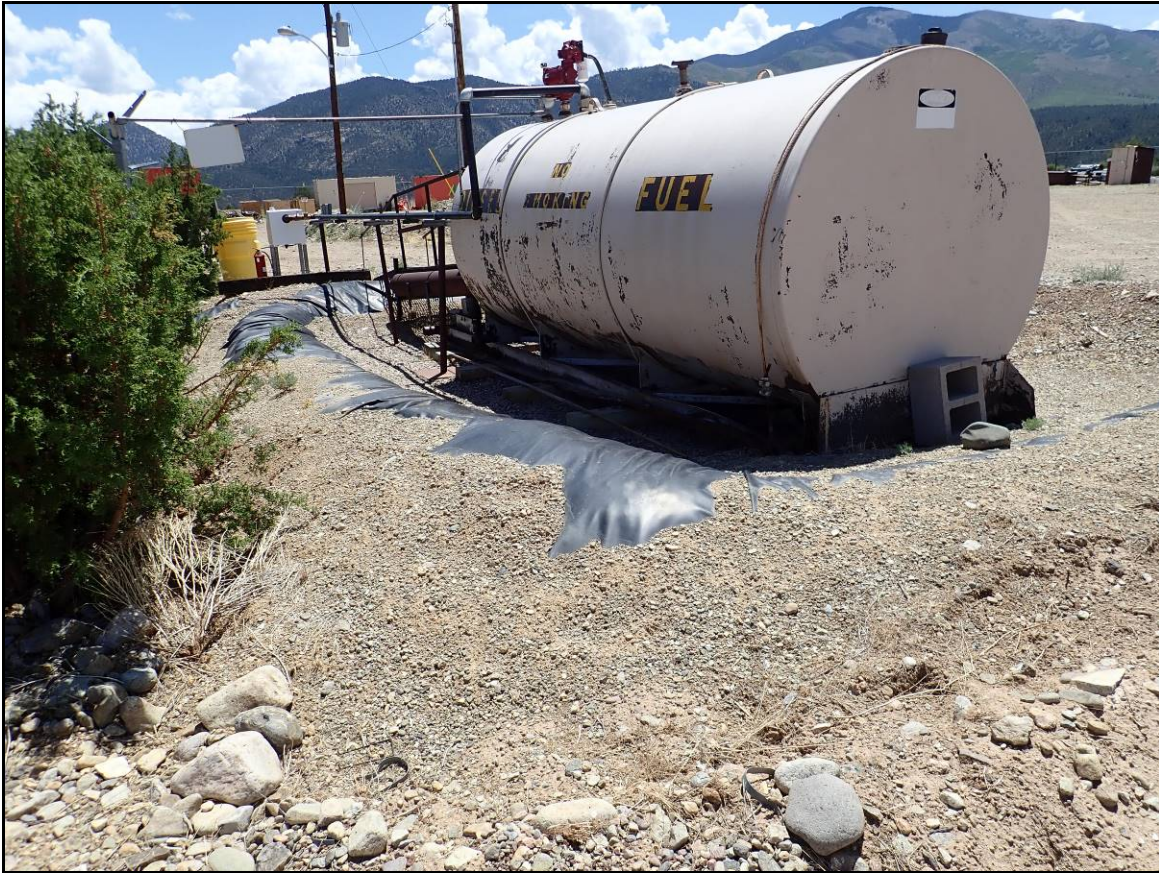
**NMED/SWQB  
Official Photograph Log  
Photo # 7**

Location: Chevron Questa Mine, Tailings Facility Entrance, Unit 14

Subject: Lined containment at fuel storage tank does not appear sufficient to contain large spills or overflows based on tank size. NMED Petroleum Storage Tank Bureau can be contacted to confirm registration and other requirements for above ground storage tanks (see [https://www.env.nm.gov/petroleum\\_storage\\_tank/](https://www.env.nm.gov/petroleum_storage_tank/)).
